AIRCRAFT ACCIDENT REPORT

AIR U.S. FLIGHT 716, HP-137, N11360,
AND SKY'S WEST CESSNA TU-206, N4862F,
MIDAIR COLLISION
FT. COLLINS/LOVELAND MUNICIPAL AIRPORT
LOVELAND, COLORADO.
APRIL 17, 1981

NTSB-AAR-81-18

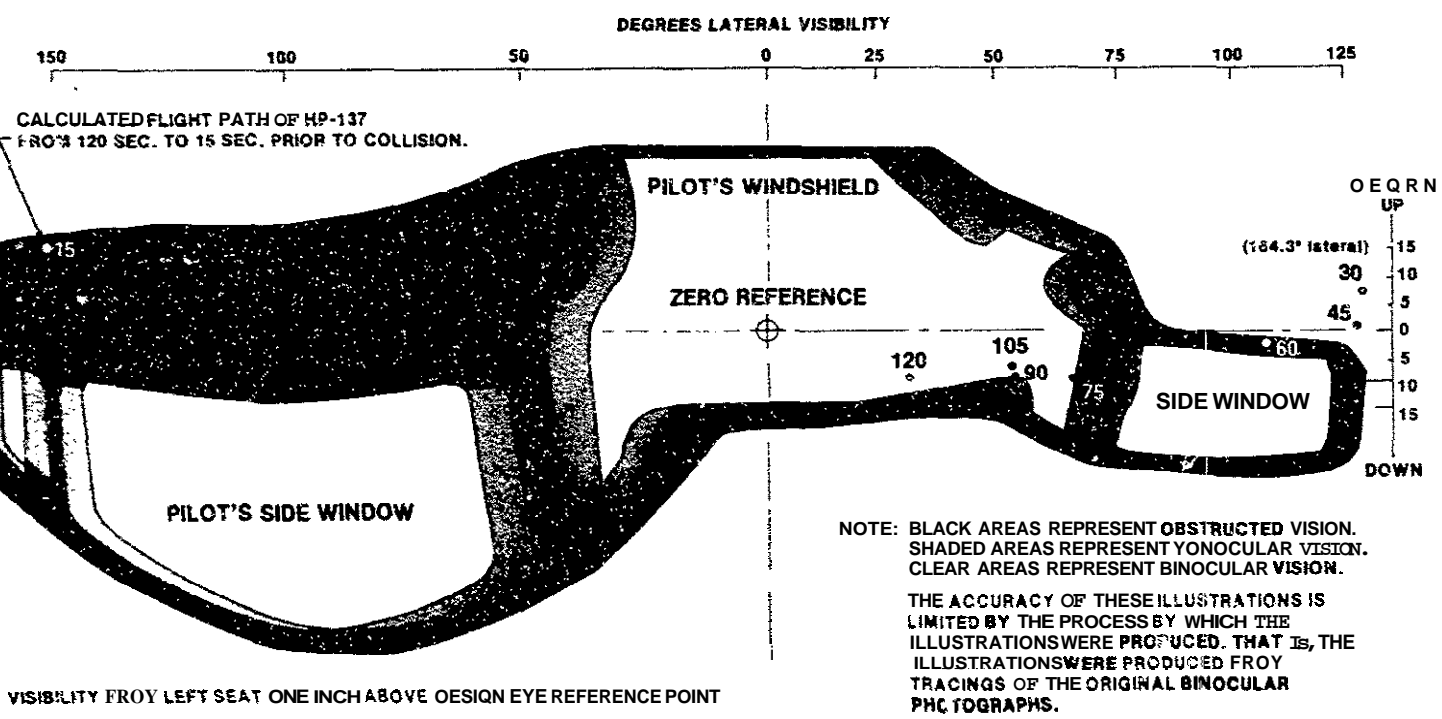
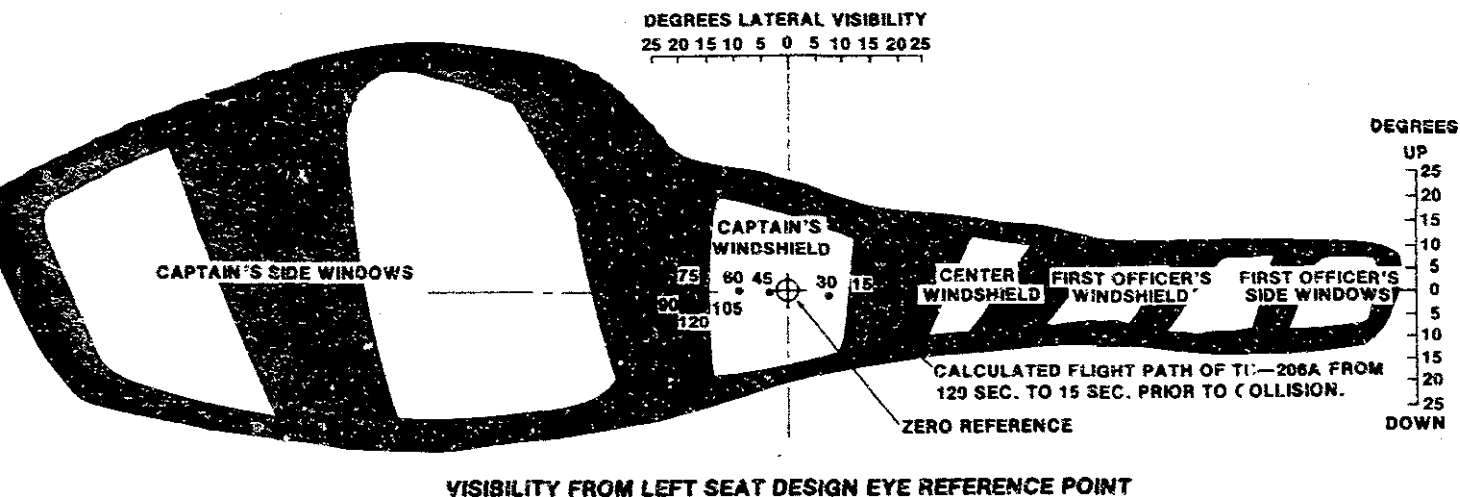
**COCKPIT VISIBILITY
CESSNA TU-206A
VIEWING HANDLN PAGE HP-137**

Examination of the photographs taken from the pilot's position indicate that the view of the Jetstream would have been unobstructed and within the binocular vision envelope of the windshield. If the pilot's eyes were in a position 1 inch above the design eye reference point, the Jetstream target would have been present within that vision envelope in the lower right hand corner very near the glare shield for a period of at least about 120 to 75 seconds before the collision. The pilot's seat was found adjusted to the full-up position. Had the pilot's seat been adjusted forward of the reference point, the over-the-me visibility would have been increased. Conversely, if the seat was located aft and/or below the reference point, the visibility near the lower edge of the windshield would have been less, due to the position of the instrument panel glare shield.

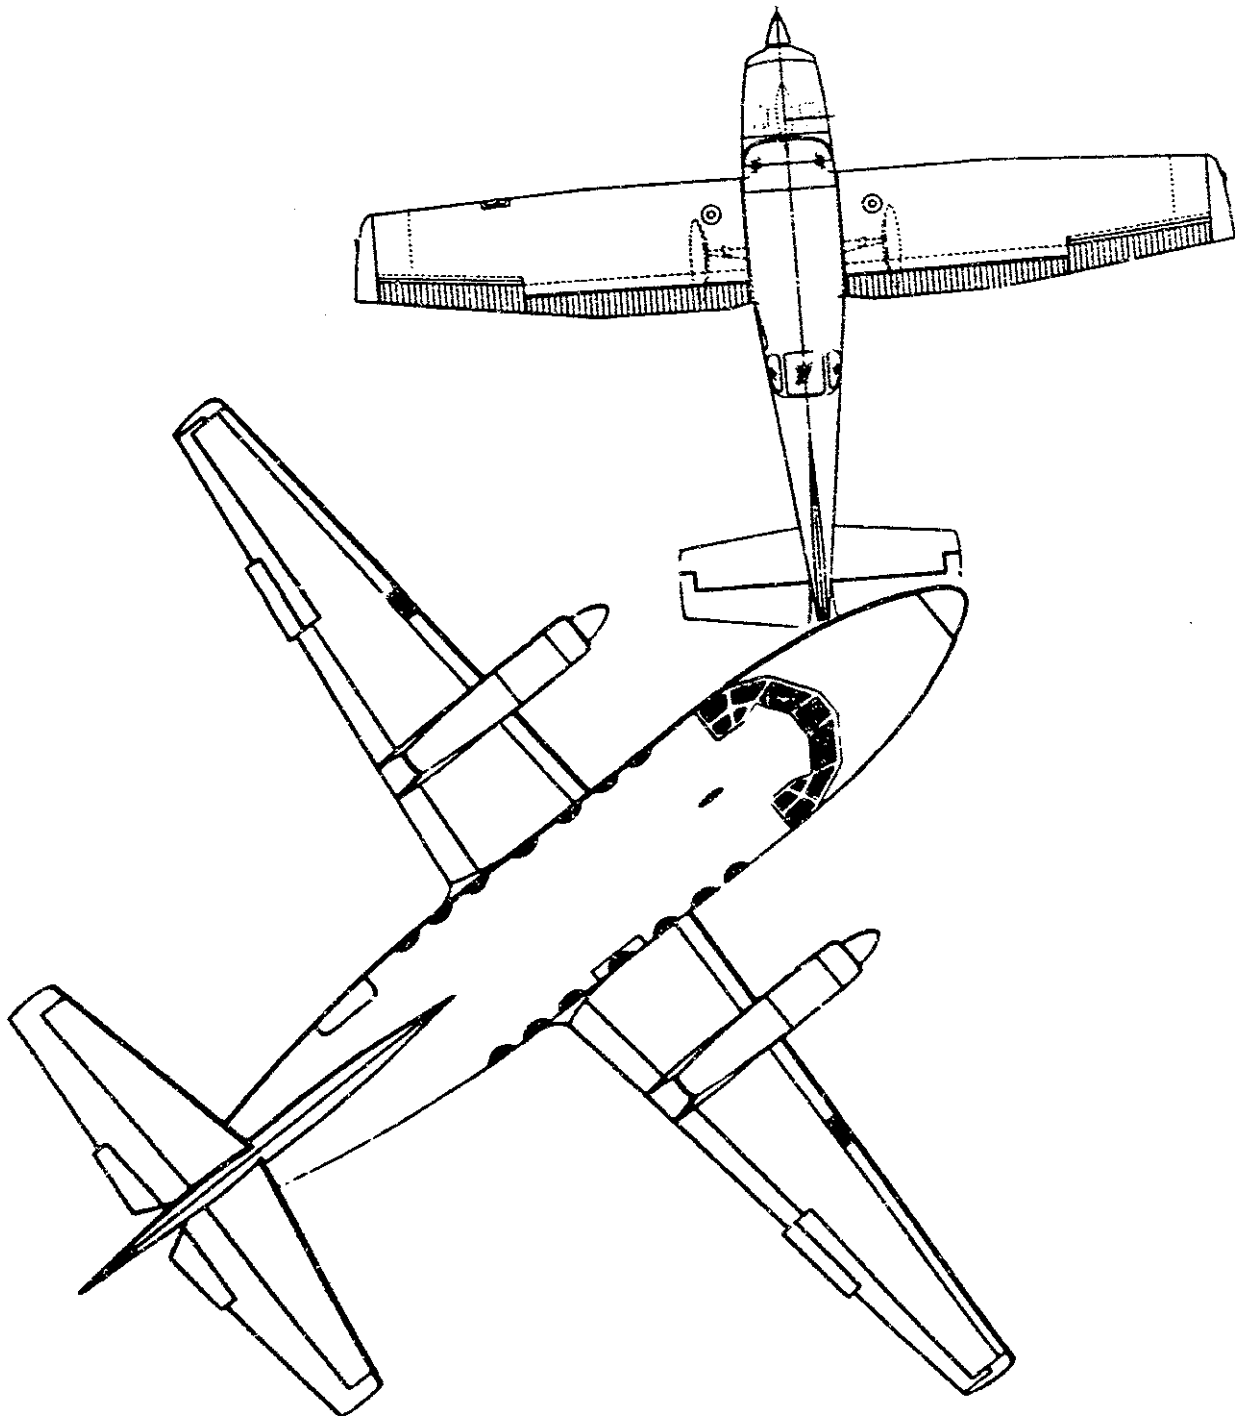
APPENDIX F
SKETCH OF ACCIDENT POSITIONS

The Cessna was in a climbing left turn on a northwesterly heading and Flight 716 was in level flight on a northerly heading. The left wing tip and fuselage nose section of the Jetstream (Flight 716) collided with the left side of the Cessna. The No. 1 propeller of the Jetstream cut through the aft fuselage section of the Cessna resulting in immediate loss of control to both aircraft. (See sketch appendix F.)
