C I V I L A E R O N A U T I C S B O A R D
AIRCRAFT ACCIDENT REPORT

Adopted: **March 8, 1965**

FRONTIER AIRLINES, INC.
DOUGLAS DC-3C, N61442
MILES CITY, MONTANA
MARCH 12, 1964

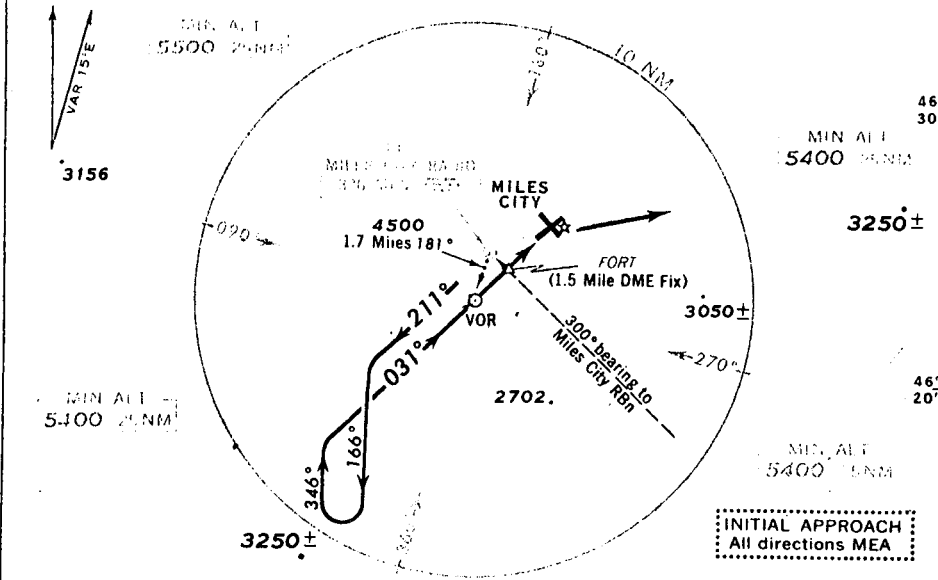
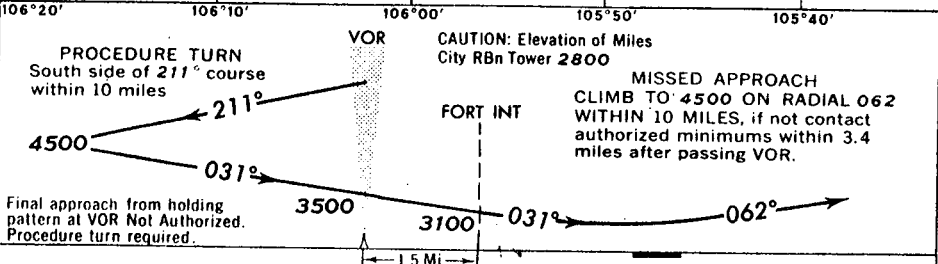
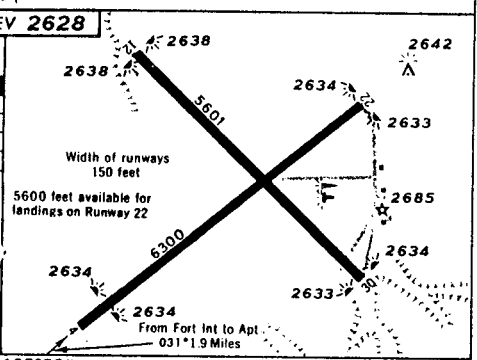
Attachment "A"
Frontier Airlines, Inc.
DC-3 N61442
Miles City, Mont. 3/12/64

^{4/} There are four FAA-approved public instrument approach procedures applicable to the MLS Airport. These are a VOR, an ADF and two VOR/DME approaches. Only the VOR or the ADF approaches could have been utilized by Flight 32 as it was not equipped with DME (Distance Measuring Equipment). (See Attachment "A")

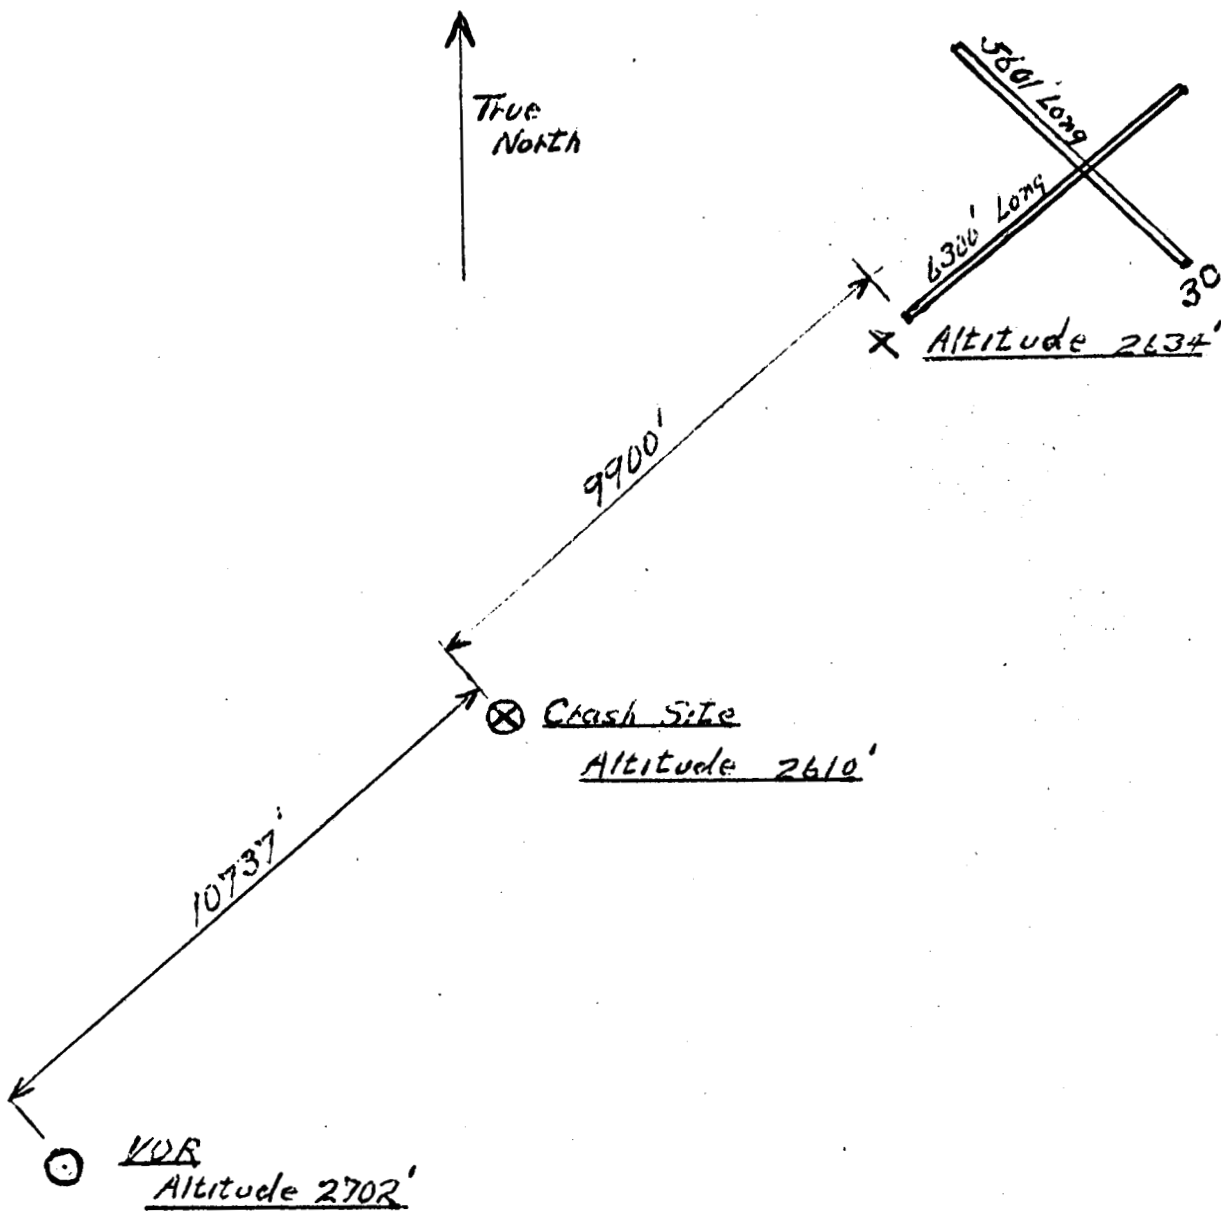
Attachment "B"

The crash site was on a 22-degree upslope at an elevation of 2610 feet m.s.l. and 9,900 feet short of the approach end of Runway 4. The airport elevation is 2,628 feet m.s.l. and that of the VOR station is 2,702 feet m.s.l. At the time of impact the aircraft's heading was about 38 degrees magnetic and the elevation of the crest of the small rise ahead was 2,615 feet m.s.l. (See Attachment "B")
