AIRCRAFT ACCIDENT REPORT

AIR U.S. FLIGHT 716, HP-137, N11360,
AND SKY'S WEST CESSNA TU-206, N4862F,
MIDAIR COLLISION
FT. COLLINS/LOVELAND MUNICIPAL AIRPORT
LOVELAND, COLORADO.
APRIL 17, 1981

NTSB-AAR-81-18

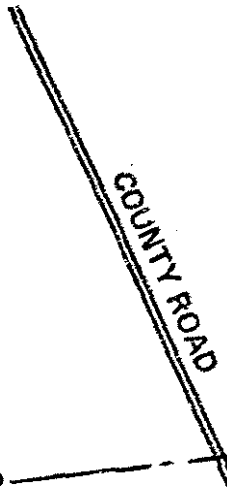
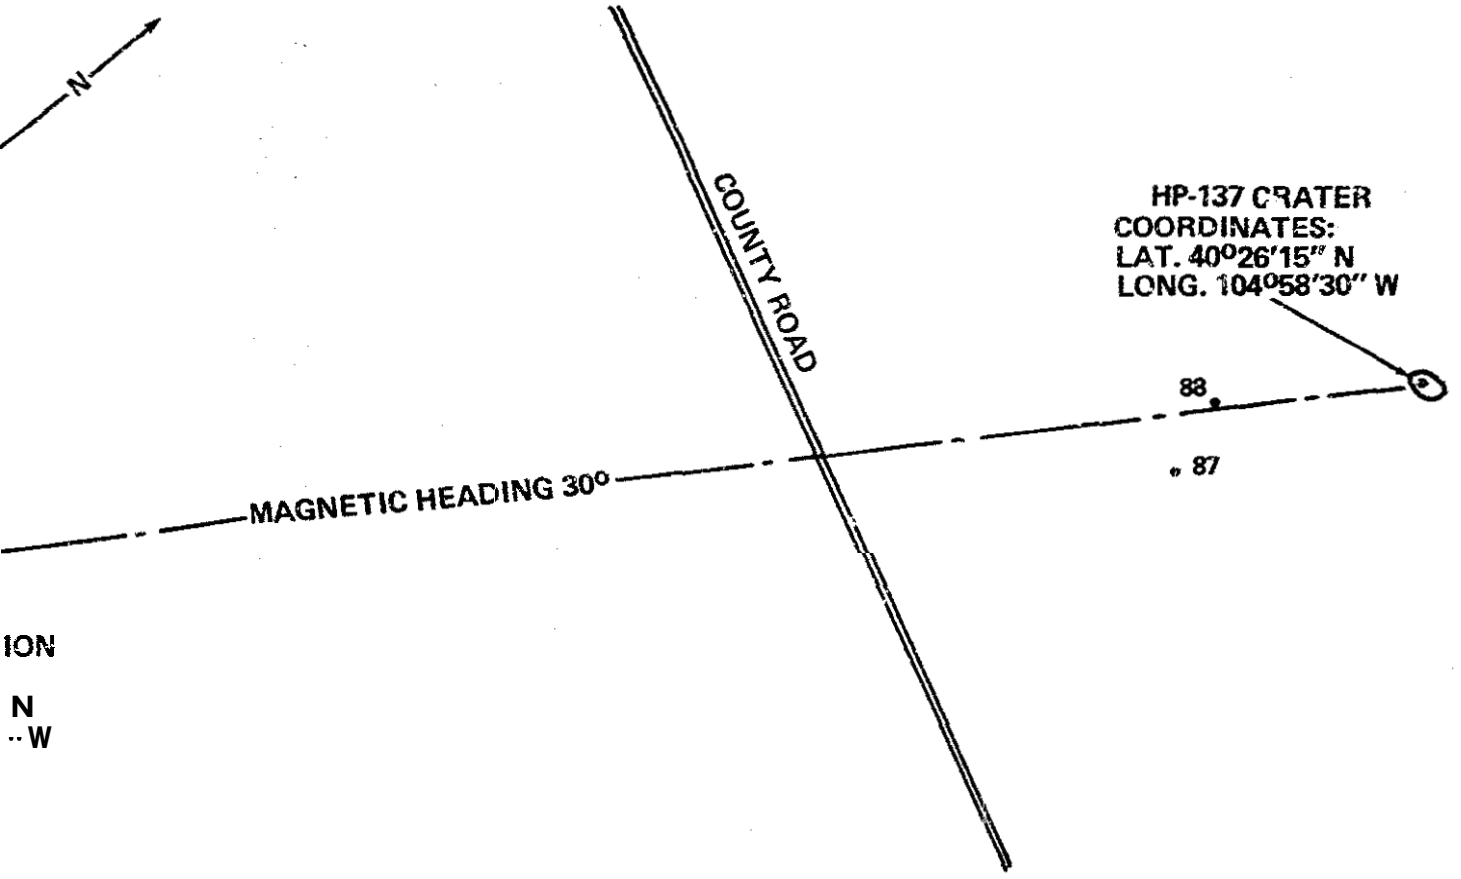
WRECKAGE DISTRIBUTION CHART

• 83
LINE—MAGNETIC HEADING 038°
• 84, 85, 86

206 NOSE SECTION
COORDINATES:
LAT. 40°25'40" N
LON. 104°58'45" W

MAGNETIC HEADING 30°
