AIRCRAFT ACCIDENT REPORT *WLO*

FRONTIER AIRLINES, INC., DC-3C, N 64424, PUEBLO, COLORADO, AUGUST 23, 1958

SYNOPSIS

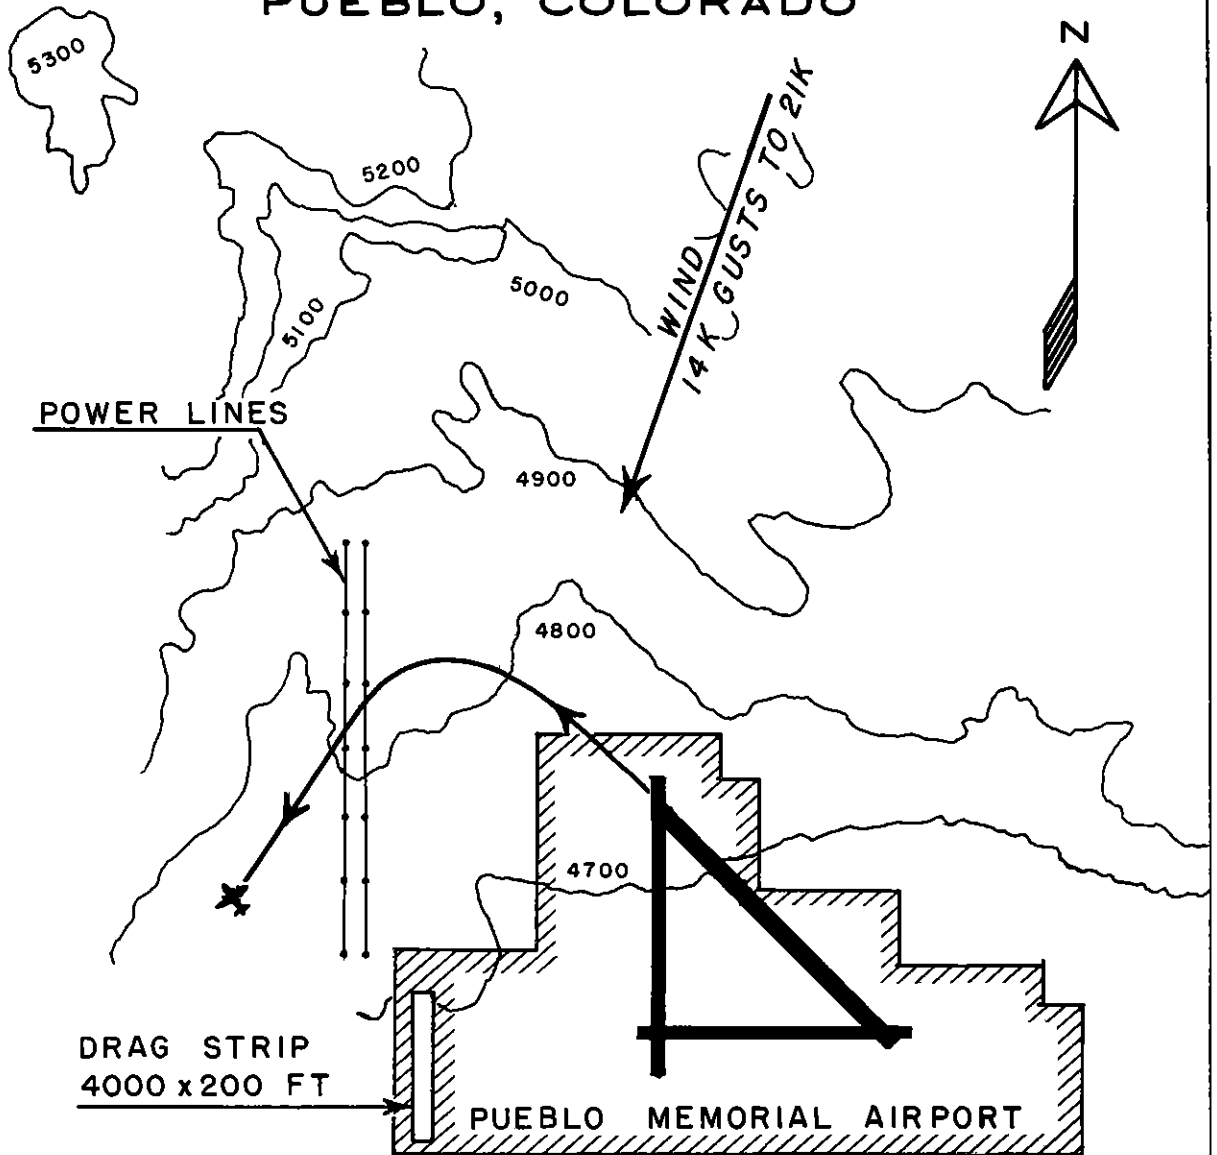
ATTACHMENT "A"

FRONTIER AIRLINES
AUGUST 23, 1958
PUEBLO MEMORIAL AIRPORT
PUEBLO, COLORADO

Scale 1" = 1 Mile
100' Contour Lines

Shortly after noon August 23, 1958, Frontier Airlines Flight 73 experienced an emergency gear-up landing two miles northwest of Pueblo Memorial Airport and two minutes after its takeoff from runway 30 of that airport. Several of the 19 passengers and crew of 3 received minor bruises; there were no serious injuries. The aircraft was substantially damaged; fire did not occur. The weather was good.

A normal takeoff was made from the Pueblo Airport by the first officer in the left pilot seat. Immediately after the aircraft became airborne and gear retraction had started, the captain, in the right pilot seat, observed the cockpit fire warning for the left engine come on. In accordance with operations manual instructions, he immediately tested the fire-warning system but the warning light remained on; the captain then feathered the left propeller. The Pueblo control tower was advised that the flight was returning to the airport and the captain took over control. Because of higher terrain ahead, a shallow left turn was made at an altitude of 50 to 75 feet and at an indicated airspeed of 95 knots. This altitude and airspeed could not be maintained. After passing under a 34-foot high power line with the airspeed dropping to 75 knots, the power was cut on the right engine. Ground contact occurred almost immediately and after a ground slide of nearly 1,000 feet the aircraft came to rest on the underside of its fuselage.
